Manhole Inspection Report

Date:	03/27/2018	Weather:		Coding:	RZMACP
MH#:	M-803-015	Owner:	NA	Len. Surveyed:	9.3
P.O.#:		Surveyor:	John Kuglmaier	Rim to Invert:	10.7
Customer:		Cert. #:	U-1215-07002349	Wall Material:	Concrete (reinforced)

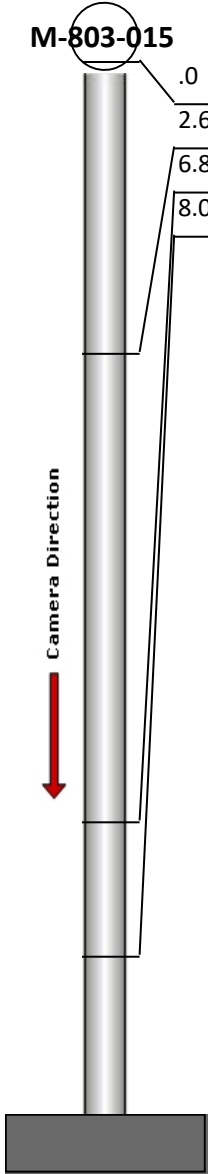
M-803-015				
	.0	MGP	General Photo	10	NA
	2.6	MGP	General Photo	29	NA
	6.8	DSF	Deposits Settled Fine	51	M 2
	8.0	MGO	General Observation	65	NA
