Manhole Inspection Report

Date:	03/27/2018	Weather:		Coding:	RZMACP
MH#:	M-803-015	Owner:	NA	Len. Surveyed:	7.9
P.O.#:		Surveyor:	John Kuglmaier	Rim to Invert:	10.0
Customer:		Cert. #:	U-1215-07002349	Wall Material:	Concrete (reinforced)

Street:	202' North of North St. 164' West of	Project:	Hobart, IN
City:	Hobart, IN	GPS Northing:	0.0
Location:		GPS Easting:	0.0
Drain Area:	Northeast	GPS Accuracy:	Nearest Meter
Cover Shape:	Circular	Evidence of Surcharge:	No
Cover Size:	23.0	Potential for Runoff:	None
Comments:

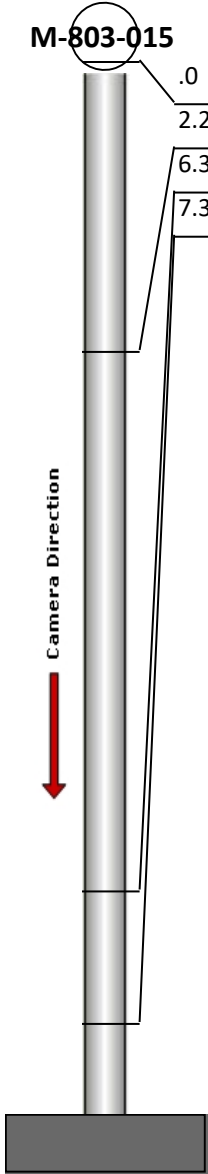
.0	MGP	General Photo	10	NA
	2.2	MGP	General Photo	28	NA
	6.3	DSF	Deposits Settled Fine	50	M 2
	7.3	MGO	General Observation	64	NA
