Manhole Inspection Report

Date:	03/27/2018	Weather:		Coding:	RZMACP
MH#:	M-803-016	Owner:	NA	Len. Surveyed:	7.2
P.O.#:		Surveyor:	John Kuglmaier	Rim to Invert:	9.0
Customer:		Cert. #:	U-1215-07002349	Wall Material:	Concrete (reinforced)

Street:	414' North of North St. 166' East of L	Project:	Hobart, IN
City:	Hobart, IN	GPS Northing:	0.0
Location:		GPS Easting:	0.0
Drain Area:	Northeast	GPS Accuracy:	Nearest Meter
Cover Shape:	Circular	Evidence of Surcharge:	Yes
Cover Size:	23.0	Potential for Runoff:	None
Comments:

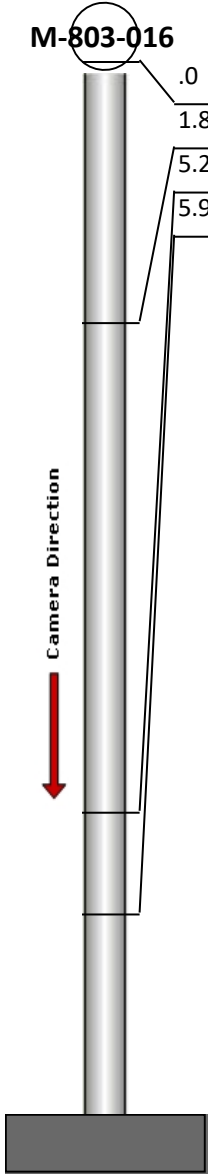
M-803-016				
	.0	MGP	General Photo	10	NA
	1.8	MGP	General Photo	27	NA
	5.2	DSF	Deposits Settled Fine	48	M 2
	5.9	MGO	General Observation	61	NA
