Manhole Inspection Report

Date:	03/29/2018	Weather:		Coding:	RZMACP
MH#:	M-803-022	Owner:	NA	Len. Surveyed:	6.0
P.O.#:		Surveyor:	John Kuglmaier	Rim to Invert:	7.3
Customer:		Cert. #:	U-1215-07002349	Wall Material:	Concrete (reinforced)

Street:	281' North of 40th Ave. 330' East of	Project:	Hobart, IN
City:	Hobart, IN	GPS Northing:	0.0
Location:		GPS Easting:	0.0
Drain Area:	Northeast	GPS Accuracy:	Nearest Meter
Cover Shape:	Circular	Evidence of Surcharge:	No
Cover Size:	23.0	Potential for Runoff:	None
Comments:

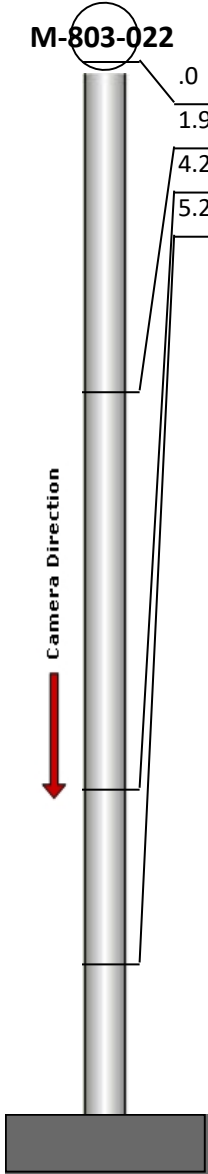
.0	MGP	General Photo	10	NA
	1.9	MGP	General Photo	28	NA
	4.2	DAZ	Deposits Attached Other	46	M 2
	5.2	MGO	General Observation	59	NA
