Manhole Inspection Report

| MH#: | M-803-023 | Owner: | NA | Len. Surveyed: | 8.8 |

| Street: | 40th Ave. 169' East of Ohio St. | Project: | Hobart, IN |

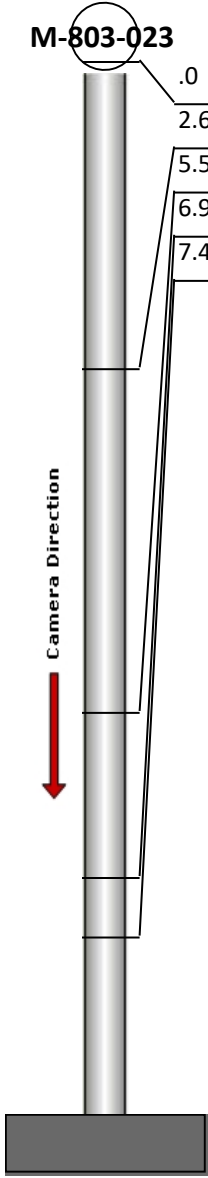
| | Position | Code | Observation | Video (sec) | Grade |
|--|---|---|---|---|---|
| | 5.5 | SAV | Surface Aggregate Visible | 49 | S 3 |
| | 6.9 | OBR | Obstacle Rocks | 63 | M 2 |
| | 7.4 | MGO | General Observation | 75 | NA |
