Manhole Inspection Report

Date:	03/27/2018	Weather:		Coding:	RZMACP
MH#:	M-803-025	Owner:	NA	Len. Surveyed:	6.5
P.O.#:		Surveyor:	John Kuglmaier	Rim to Invert:	7.9
Customer:		Cert. #:	U-1215-07002349	Wall Material:	Concrete (reinforced)

Street:	67' North of High St. 168' East of Ohi	Project:	Hobart, IN
City:	Hobart, IN	GPS Northing:	0.0
Location:		GPS Easting:	0.0
Drain Area:	Northeast	GPS Accuracy:	Nearest Meter
Cover Shape:	Circular	Evidence of Surcharge:	Yes
Cover Size:	23.0	Potential for Runoff:	None
Comments:

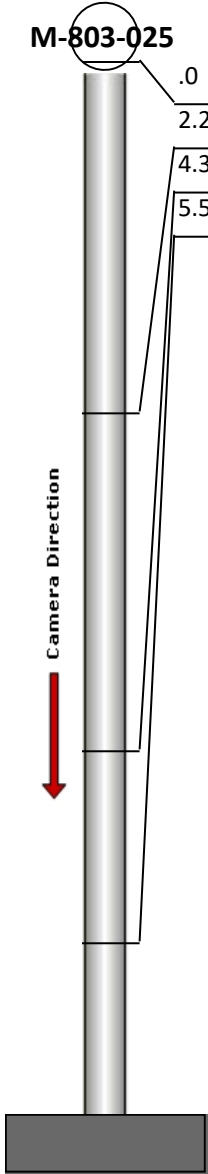
Position	Code	Observation	Video (sec)	Grade

.0	MGP	General Photo	10	NA
	2.2	MGP	General Photo	28	NA
	4.3	DAZ	Deposits Attached Other	46	M 3
	5.5	MGO	General Observation	60	NA
