Manhole Inspection Report

Date:	03/28/2018	Weather:		Coding:	RZMACP
MH#:	M-803-027	Owner:	NA	Len. Surveyed:	11.0
P.O.#:		Surveyor:	John Kuglmaier	Rim to Invert:	11.7
Customer:		Cert. #:	U-1215-07002349	Wall Material:	Concrete (reinforced)

Street:	Intersection of Rand St. and Lawren	Project:	Hobart, IN
City:	Hobart, IN	GPS Northing:	0.0
Location:		GPS Easting:	0.0
Drain Area:	Northeast	GPS Accuracy:	Nearest Meter
Cover Shape:	Circular	Evidence of Surcharge:	No
Cover Size:	23.0	Potential for Runoff:	None
Comments:

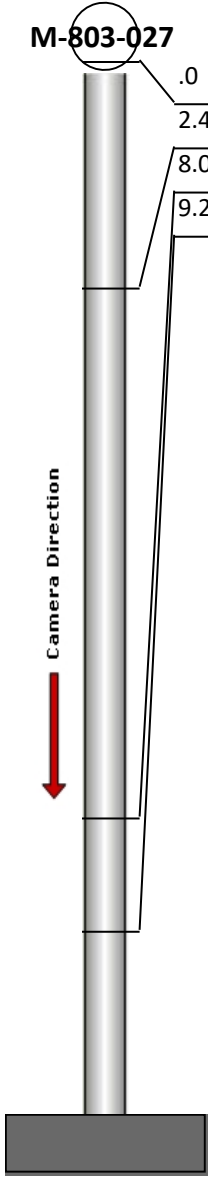
M-803-027				
	.0	MGP	General Photo	10	NA
	2.4	MGP	General Photo	29	NA
	8.0	DAZ	Deposits Attached Other	54	M 2
	9.2	MGO	General Observation	67	NA
