Manhole Inspection Report

Date:	03/29/2018	Weather:		Coding:	RZMACP
MH#:	M-803-033	Owner:	NA	Len. Surveyed:	7.0
P.O.#:		Surveyor:	John Kuglmaier	Rim to Invert:	8.7
Customer:		Cert. #:	U-1215-07002349	Wall Material:	Concrete (reinforced)

Street:	269' South of 40th Ave. 164' East Ind	Project:	Hobart, IN
City:	Hobart, IN	GPS Northing:	0.0
Location:		GPS Easting:	0.0
Drain Area:	Northeast	GPS Accuracy:	Nearest Meter
Cover Shape:	Circular	Evidence of Surcharge:	No
Cover Size:	23.0	Potential for Runoff:	None
Comments:

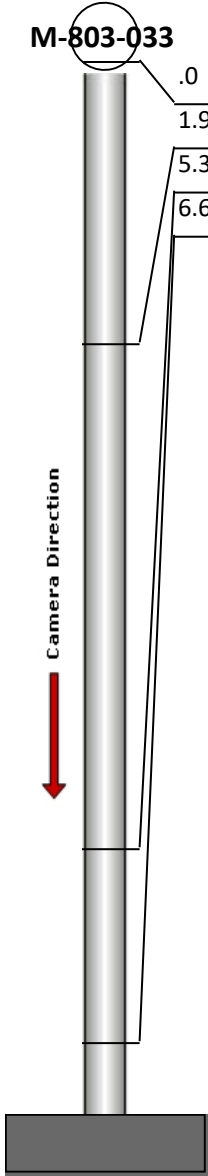
M-803-033				
	.0	MGP	General Photo	10	NA
	1.9	MGP	General Photo	27	NA
	5.3	RFB	Roots Fine Barrel	48	M 2
	6.6	MGO	General Observation	62	NA
