Manhole Inspection Report

Date:	03/26/2018	Weather:		Coding:	RZMACP
MH#:	M-803-048	Owner:	NA	Len. Surveyed:	4.7
P.O.#:		Surveyor:	John Kuglmaier	Rim to Invert:	5.7
Customer:		Cert. #:	U-1215-07002349	Wall Material:	Concrete (reinforced)

Street:	Kelly St. 214' North of High St.	Project:	Hobart, IN
City:	Hobart, IN	GPS Northing:	0.0
Location:		GPS Easting:	0.0
Drain Area:	Northeast	GPS Accuracy:	Nearest Meter
Cover Shape:	Circular	Evidence of Surcharge:	No
Cover Size:	23.0	Potential for Runoff:	None
Comments:

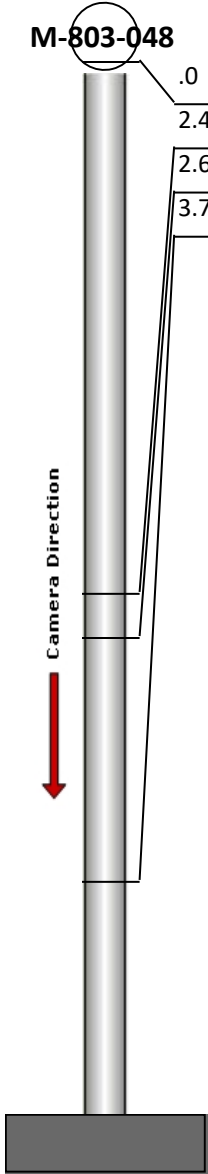
.0	MGP	General Photo	10	NA
	2.4	MGP	General Photo	29	NA
	2.6	DSF	Deposits Settled Fine	43	M 2
	3.7	MGO	General Observation	56	NA
