Manhole Inspection Report

Date:	03/26/2018	Weather:		Coding:	RZMACP
MH#:	M-803-051	Owner:	NA	Len. Surveyed:	8.1
P.O.#:		Surveyor:	John Kuglmaier	Rim to Invert:	9.1
Customer:		Cert. #:	U-1215-07002349	Wall Material:	Concrete (reinforced)

Street:	Intersection of 40th Ave. and Kelly S	Project:	Hobart, IN
City:	Hobart, IN	GPS Northing:	0.0
Location:		GPS Easting:	0.0
Drain Area:	Northeast	GPS Accuracy:	Nearest Meter
Cover Shape:	Circular	Evidence of Surcharge:	No
Cover Size:	23.0	Potential for Runoff:	None
Comments:

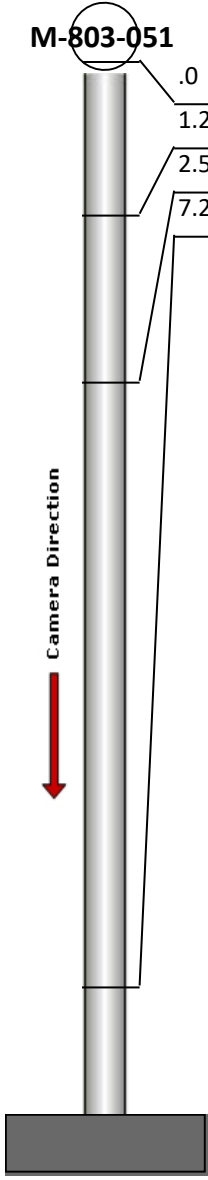
.0	MGP	General Photo	10	NA
	1.2	OBZ	Obstacle Other	24	M 2
	2.5	MGP	General Photo	40	NA
	7.2	MGO	General Observation	63	NA
