Manhole Inspection Report

Date:	03/21/2018	Weather:		Coding:	RZMACP
MH#:	M-803-060	Owner:	NA	Len. Surveyed:	6.2
P.O.#:		Surveyor:	John Kuglmaier	Rim to Invert:	7.7
Customer:		Cert. #:	U-1215-07002349	Wall Material:	Concrete (reinforced)

Street:	227' S Hwy 6.	Project:	Hobart, IN
City:	Hobart, IN	GPS Northing:	0.0
Location:		GPS Easting:	0.0
Drain Area:	Northeast	GPS Accuracy:	Nearest Meter
Cover Shape:	Circular	Evidence of Surcharge:	Yes
Cover Size:	23.0	Potential for Runoff:	None
Comments:

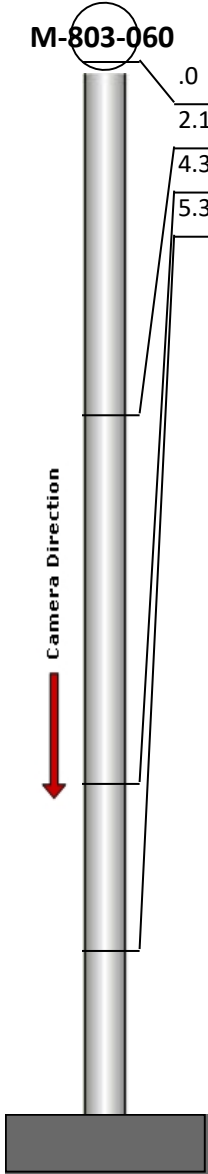
.0	MGP	General Photo	10	NA
	2.1	MGP	General Photo	28	NA
	4.3	DAZ	Deposits Attached Other	46	M 2
	5.3	MGO	General Observation	60	NA
