Manhole Inspection Report

Date:	03/24/2018	Weather:		Coding:	RZMACP
MH#:	M-803-063	Owner:	NA	Len. Surveyed:	7.4
P.O.#:		Surveyor:	John Kuglmaier	Rim to Invert:	8.0
Customer:		Cert. #:	U-1215-07002349	Wall Material:	Concrete (reinforced)

Street:	218' S Hwy 6. The East Side.	Project:	Hobart, IN
City:	Hobart, IN	GPS Northing:	0.0
Location:		GPS Easting:	0.0
Drain Area:	Northeast	GPS Accuracy:	Nearest Meter
Cover Shape:	Circular	Evidence of Surcharge:	No
Cover Size:	23.0	Potential for Runoff:	None
Comments:

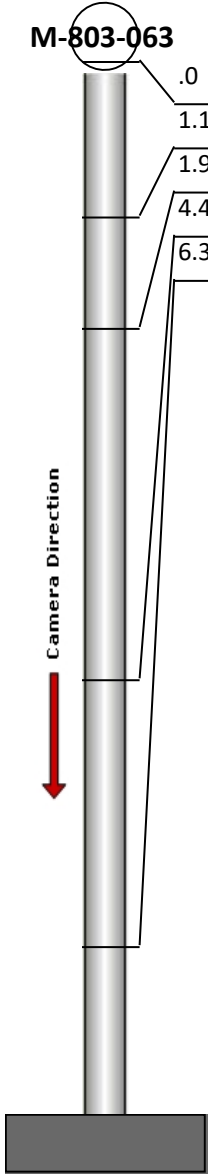
.0	MGP	General Photo	10	NA
	1.1	IS	Infil Stain	24	NA
	1.9	MGP	General Photo	39	NA
	4.4	IS	Infil Stain	58	NA
	6.3	MGO	General Observation	73	NA
