Manhole Inspection Report

Date:	05/07/2018	Weather:		Coding:	RZMACP
MH#:	M-804-004	Owner:	NA	Len. Surveyed:	6.8
P.O.#:		Surveyor:	Jen Costello	Rim to Invert:	7.2
Customer:		Cert. #:	U-907-5518	Wall Material:	Concrete (reinforced)

Street:	South of Jackson St. 785' West of H	Project:	Hobart, IN
City:	Hobart, IN	GPS Northing:	2908972.634
Location:		GPS Easting:	2908972.634
Drain Area:	South	GPS Accuracy:	Sub-Meter
Cover Shape:	Circular	Evidence of Surcharge:	No
Cover Size:	22.5	Potential for Runoff:	None
Comments:

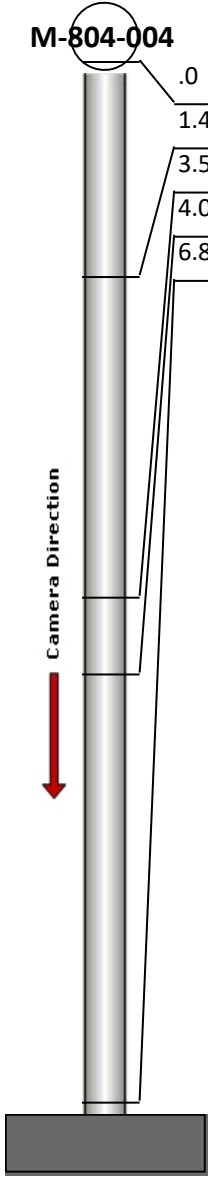
.0	MGP	General Photo	10	NA
	1.4	MGO	General Observation	26	NA
	3.5	OBZ	Obstacle Other	44	M 2
	4.0	MGO	General Observation	56	NA
	6.8	MGO	General Observation	73	NA
