Manhole Inspection Report

Date:	05/07/2018	Weather:		Coding:	RZMACP
MH#:	M-804-011	Owner:	NA	Len. Surveyed:	7.2
P.O.#:		Surveyor:	Jen Costello	Rim to Invert:	7.7
Customer:		Cert. #:	U-907-5518	Wall Material:	Brick

Street:	Cleveland Ave. 454' East of Illinois St	Project:	Hobart, IN
City:	Hobart, IN	GPS Northing:	2907973.454
Location:		GPS Easting:	2907973.454
Drain Area:	South	GPS Accuracy:	Sub-Meter
Cover Shape:	Circular	Evidence of Surcharge:	No
Cover Size:	22.5	Potential for Runoff:	None
Comments:

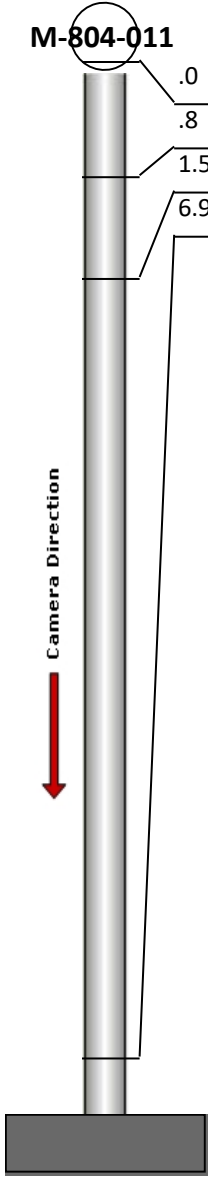
.0	MGP	General Photo	10	NA
	.8	DAE	Deposits Attached Encrustation	23	M 2
	1.5	MGO	General Observation	38	NA
	6.9	MGO	General Observation	62	NA
