Manhole Inspection Report

Date:	05/06/2018	Weather:		Coding:	RZMACP
MH#:	M-804-012	Owner:	NA	Len. Surveyed:	3.2
P.O.#:		Surveyor:	Jen Costello	Rim to Invert:	4.1
Customer:		Cert. #:	U-907-5518	Wall Material:	Concrete (reinforced)

Street:	Cleveland Ave. 238' East of Illinois St	Project:	Hobart, IN
City:	Hobart, IN	GPS Northing:	2907762.96
Location:		GPS Easting:	2907762.96
Drain Area:	South	GPS Accuracy:	Sub-Meter
Cover Shape:	Circular	Evidence of Surcharge:	No
Cover Size:	22.5	Potential for Runoff:	None
Comments:

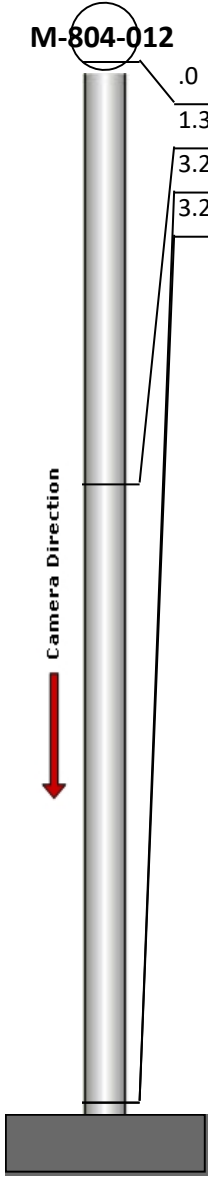
M-804-012				
	.0	MGP	General Photo	10	NA
	1.3	MGO	General Observation	26	NA
	3.2	DSZ	Deposits Settled Other	43	M 2
	3.2	MGO	General Observation	54	NA
