Manhole Inspection Report

Date:	05/06/2018	Weather:		Coding:	RZMACP
MH#:	M-804-013	Owner:	NA	Len. Surveyed:	9.7
P.O.#:		Surveyor:	Jen Costello	Rim to Invert:	10.4
Customer:		Cert. #:	U-907-5518	Wall Material:	Brick

Street:	Corner of Kelly St. and Home Ave.	Project:	Hobart, IN
City:	Hobart, IN	GPS Northing:	2907761.028
Location:		GPS Easting:	2907761.028
Drain Area:	Northeast	GPS Accuracy:	Sub-Meter
Cover Shape:	Circular	Evidence of Surcharge:	No
Cover Size:	22.5	Potential for Runoff:	None
Comments:

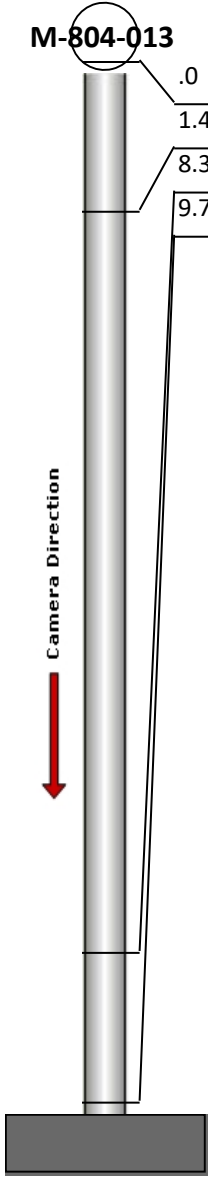
.0	MGP	General Photo	10	NA
	1.4	MGO	General Observation	26	NA
	8.3	DSGV	Deposits Settled Gravel	53	M 2
	9.7	DB	Displaced Brick	68	S 3
