Manhole Inspection Report

Date:	05/06/2018	Weather:		Coding:	RZMACP
MH#:	M-804-014	Owner:	NA	Len. Surveyed:	8.9
P.O.#:		Surveyor:	Jen Costello	Rim to Invert:	9.7
Customer:		Cert. #:	U-907-5518	Wall Material:	Brick

Street:	Home Ave. 56' West of Illinois St.	Project:	Hobart, IN
City:	Hobart, IN	GPS Northing:	2907376.015
Location:		GPS Easting:	2907376.015
Drain Area:	Northeast	GPS Accuracy:	Sub-Meter
Cover Shape:	Circular	Evidence of Surcharge:	No
Cover Size:	22.5	Potential for Runoff:	None
Comments:

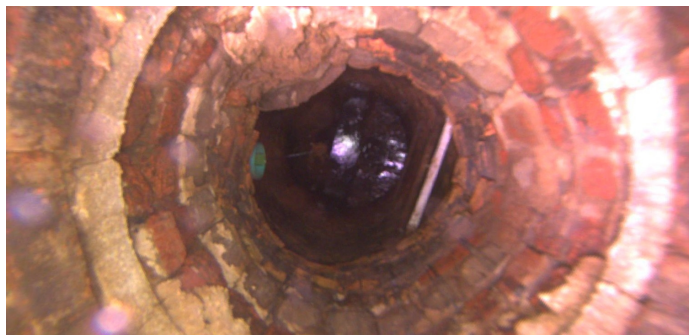
Code: **MGP**
Description: **General Photo**

Distance (ft): **.0**
Structural Grade: **0**
O&M Grade: **0**
Clock Start/From:
Clock To:
1st Value:
2nd Value:
Value Percent:
Step: **NO**
Remarks: **ACCESS MH**

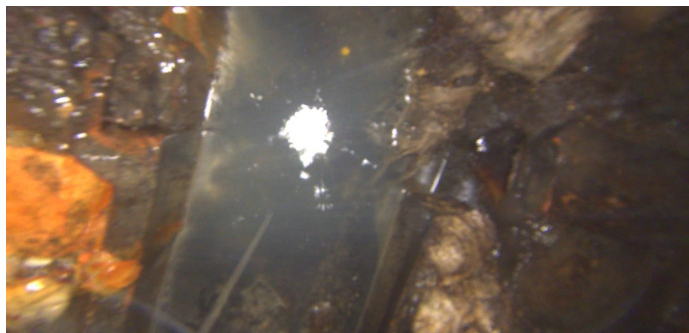
Code: **MGO**
Description: **General Observation**

Distance (ft): **8.9**
Structural Grade: **0**
O&M Grade: **0**
Clock Start/From:
Clock To:
1st Value:
2nd Value:
Value Percent:
Step: **NO**
Remarks: **END SURVEY**
