Manhole Inspection Report

Date:	05/15/2018	Weather:		Coding:	RZMACP
MH#:	M-804-046	Owner:	NA	Len. Surveyed:	4.7
P.O.#:		Surveyor:	Jen Costello	Rim to Invert:	5.3
Customer:		Cert. #:	U-907-5518	Wall Material:	Concrete (reinforced)

Street:	166' South of High St. 367' West of L	Project:	Hobart, IN
City:	Hobart, IN	GPS Northing:	2908686.338
Location:		GPS Easting:	2908686.338
Drain Area:	Northeast	GPS Accuracy:	Sub-Meter
Cover Shape:	Circular	Evidence of Surcharge:	No
Cover Size:	22.5	Potential for Runoff:	None
Comments:

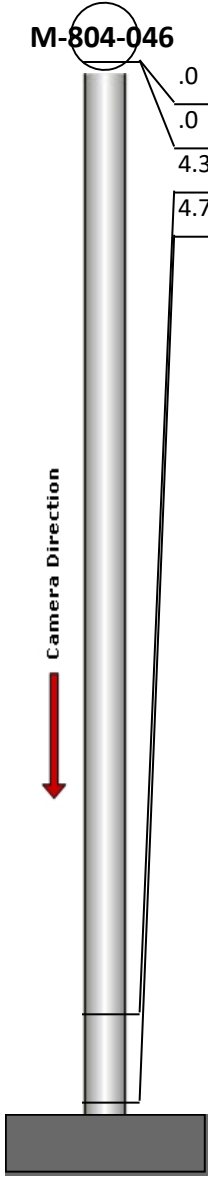
.0	MGP	General Photo	10	NA
	.0	RFJ	Roots Fine Joint	22	M 1
	4.3	DSF	Deposits Settled Fine	42	M 2
	4.7	MGO	General Observation	54	NA
