Manhole Inspection Report

Date:	05/16/2018	Weather:		Coding:	RZMACP
MH#:	M-804-058	Owner:	NA	Len. Surveyed:	10.3
P.O.#:		Surveyor:	Jen Costello	Rim to Invert:	11.4
Customer:		Cert. #:	U-907-5518	Wall Material:	Concrete (reinforced)

Street:	Linda St. 268' North of Hickey St.	Project:	Hobart, IN
City:	Hobart, IN	GPS Northing:	2907088.652
Location:		GPS Easting:	2907088.652
Drain Area:	Northeast	GPS Accuracy:	Sub-Meter
Cover Shape:	Circular	Evidence of Surcharge:	No
Cover Size:	22.5	Potential for Runoff:	None
Comments:

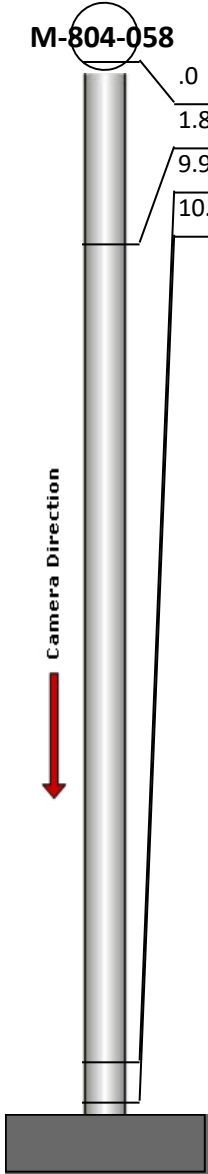
M-804-058				
	.0	MGP	General Photo	10	NA
	1.8	MGO	General Observation	27	NA
	9.9	B	Broken	57	S 5
	10.3	MGO	General Observation	69	NA
