Manhole Inspection Report

Date:	05/16/2018	Weather:		Coding:	RZMACP
MH#:	M-804-060	Owner:	NA	Len. Surveyed:	8.4
P.O.#:		Surveyor:	Jen Costello	Rim to Invert:	8.9
Customer:		Cert. #:	U-907-5518	Wall Material:	Concrete (reinforced)

Street:	Linda St. 260' South of South St.	Project:	Hobart, IN
City:	Hobart, IN	GPS Northing:	2907084.478
Location:		GPS Easting:	2907084.478
Drain Area:	Northeast	GPS Accuracy:	Sub-Meter
Cover Shape:	Circular	Evidence of Surcharge:	No
Cover Size:	22.5	Potential for Runoff:	None
Comments:

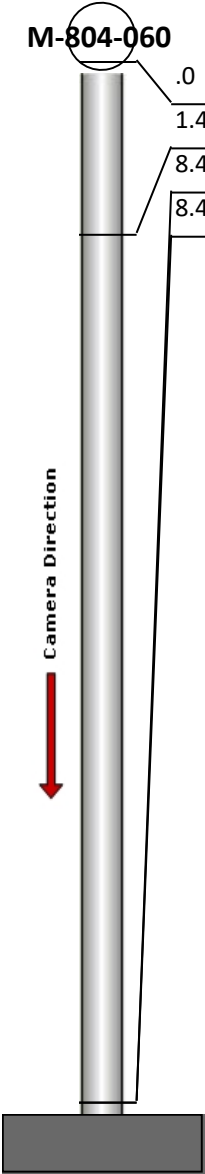
</div>	.0	MGP	General Photo	10	NA
	1.4	MGO	General Observation	26	NA
	8.4	MGO	General Observation	52	NA
	8.4	OBR	Obstacle Rocks	63	M 2
