# Manhole Inspection Report

Date:	05/06/2018	Weather:		Coding:	RZMACP
MH#:	M-804-077	Owner:	NA	Len. Surveyed:	16.2
P.O.#:		Surveyor:	Jen Costello	Rim to Invert:	18.3
Customer:		Cert. #:	U-907-5518	Wall Material:	Concrete (reinforced)

Street:	Linda St. and Home Ave. To the East.	Project:	Hobart, IN
City:	Hobart, IN	GPS Northing:	2907136.183
Location:		GPS Easting:	2907136.183
Drain Area:	Northeast	GPS Accuracy:	Sub-Meter
Cover Shape:	Circular	Evidence of Surcharge:	No
Cover Size:	22.5	Potential for Runoff:	None
Comments:

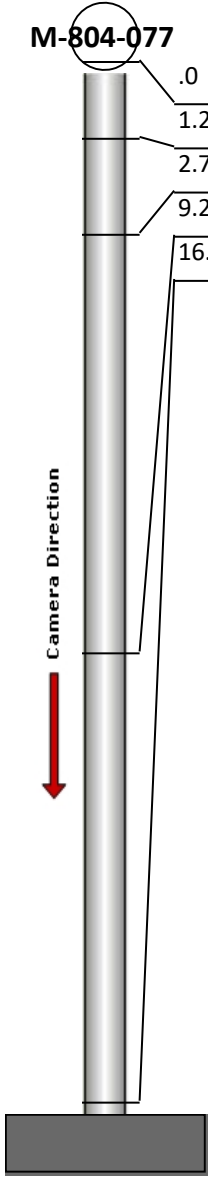
.0	MGP	General Photo	10	NA
	1.2	CL	Crack Longitudinal	24	S 2
	2.7	MGO	General Observation	41	NA
	9.2	SAV	Surface Aggregate Visible	68	S 3
	16.2	MGO	General Observation	94	NA
