Manhole Inspection Report

Date:	05/09/2018	Weather:		Coding:	RZMACP
MH#:	M-805-008	Owner:	NA	Len. Surveyed:	8.4
P.O.#:		Surveyor:	Jen Costello	Rim to Invert:	9.0
Customer:		Cert. #:	U-907-5518	Wall Material:	Concrete (reinforced)

Street:	219' South of 5th St. East of Liberty	Project:	Hobart, IN
City:	Hobart, IN	GPS Northing:	2909285.663
Location:		GPS Easting:	2909285.663
Drain Area:	Southeast	GPS Accuracy:	Sub-Meter
Cover Shape:	Circular	Evidence of Surcharge:	No
Cover Size:	22.5	Potential for Runoff:	None
Comments:

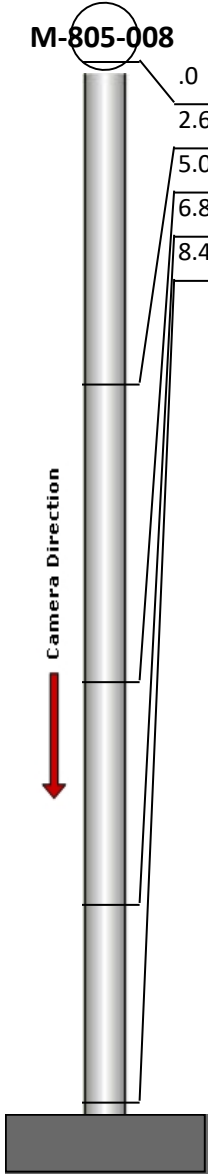
.0	MGP	General Photo	10	NA
	2.6	MGO	General Observation	29	NA
	5.0	IS	Infil Stain	47	NA
	6.8	DSGV	Deposits Settled Gravel	62	M 2
	8.4	MGO	General Observation	77	NA
