# Manhole Inspection Report

Date:	05/09/2018	Weather:		Coding:	RZMACP
MH#:	M-805-010	Owner:	NA	Len. Surveyed:	10.3
P.O.#:		Surveyor:	Jen Costello	Rim to Invert:	10.4
Customer:		Cert. #:	U-907-5518	Wall Material:	Concrete (reinforced)

Street:	250' North of 5th St. East of Liberty	Project:	Hobart, IN
City:	Hobart, IN	GPS Northing:	2909290.257
Location:		GPS Easting:	2909290.257
Drain Area:	Southeast	GPS Accuracy:	Sub-Meter
Cover Shape:	Circular	Evidence of Surcharge:	No
Cover Size:	24.0	Potential for Runoff:	None
Comments:

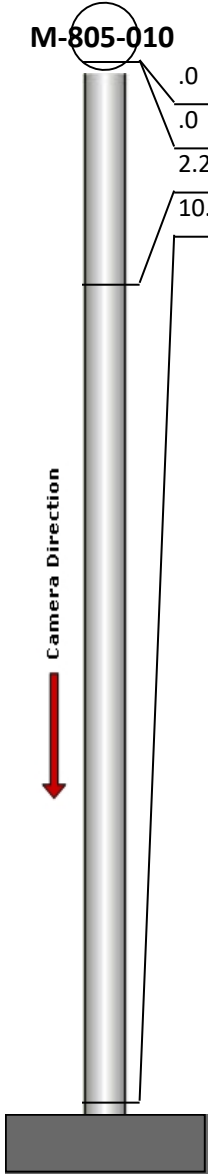
.0	MGP	General Photo	10	NA
	.0	IS	Infil Stain	21	NA
	2.2	MGO	General Observation	39	NA
	10.3	MGO	General Observation	67	NA
