# Manhole Inspection Report

| MH#: | M-805-034 | Owner: | NA | Len. Surveyed: | 17.3 |

| Street: | Indiana St. 357' South of 4th St. | Project: | Hobart, IN |

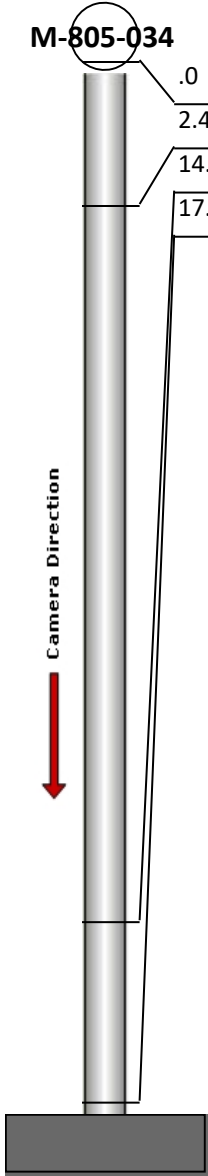
| | Position | Code | Observation | Video (sec) | Grade |
|--|---|---|---|---|---|
| | M-805-034 | | | | |

| | Position | Code | Observation | Video (sec) | Grade |
|--|---|---|---|---|---|
| | .0 | MGP | General Photo | 10 | NA |
| | 2.4 | MGO | General Observation | 29 | NA |
| | 14.3 | SAV | Surface Aggregate Visible | 66 | S 3 |
| | 17.3 | MGO | General Observation | 84 | NA |
