Manhole Inspection Report

Date:	05/07/2018	Weather:		Coding:	RZMACP
MH#:	M-805-039	Owner:	NA	Len. Surveyed:	7.2
P.O.#:		Surveyor:	Jen Costello	Rim to Invert:	7.9
Customer:		Cert. #:	U-907-5518	Wall Material:	Concrete (reinforced)

Street:	Intersection of Joliet St. and Devons	Project:	Hobart, IN
City:	Hobart, IN	GPS Northing:	2908776.134
Location:		GPS Easting:	2908776.134
Drain Area:	South	GPS Accuracy:	Sub-Meter
Cover Shape:	Circular	Evidence of Surcharge:	No
Cover Size:	22.5	Potential for Runoff:	None
Comments:

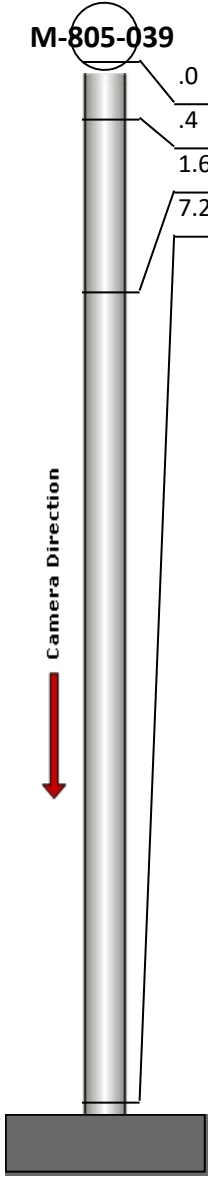
Position	Code	Observation	Video (sec)	Grade

.0	MGP	General Photo	10	NA
	.4	DB	Displaced Brick	22	S 3
	1.6	MGO	General Observation	37	NA
	7.2	MGO	General Observation	61	NA
