Manhole Inspection Report

Date:	05/04/2018	Weather:		Coding:	RZMACP
MH#:	M-805-045	Owner:	NA	Len. Surveyed:	6.5
P.O.#:		Surveyor:	Jen Costello	Rim to Invert:	6.7
Customer:		Cert. #:	U-907-5518	Wall Material:	Brick

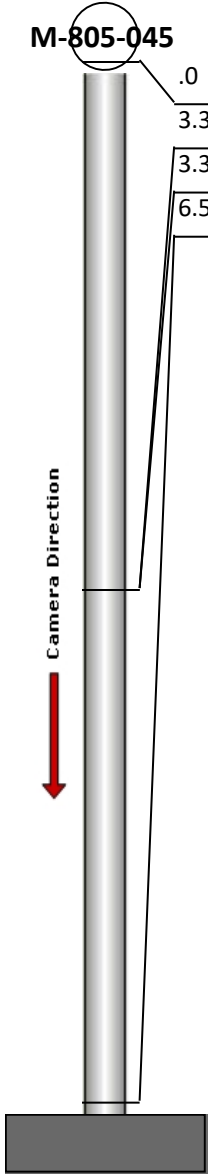
M-805-045				
	.0	MGP	General Photo	10	NA
	3.3	MGO	General Observation	30	NA
	3.3	RFB	Roots Fine Barrel	44	M 2
	6.5	MGO	General Observation	61	NA
