# Manhole Inspection Report

Date:	05/03/2018	Weather:		Coding:	RZMACP
MH#:	M-805-047	Owner:	NA	Len. Surveyed:	8.5
P.O.#:		Surveyor:	Jen Costello	Rim to Invert:	9.3
Customer:		Cert. #:	U-907-5518	Wall Material:	Brick

Street:	3rd St. 203' North of Franklin St.	Project:	Hobart, IN
City:	Hobart, IN	GPS Northing:	41.53372192
Location:		GPS Easting:	-87.2485199
Drain Area:	South	GPS Accuracy:	Nearest Meter
Cover Shape:	Circular	Evidence of Surcharge:	No
Cover Size:	22.5	Potential for Runoff:	None
Comments:

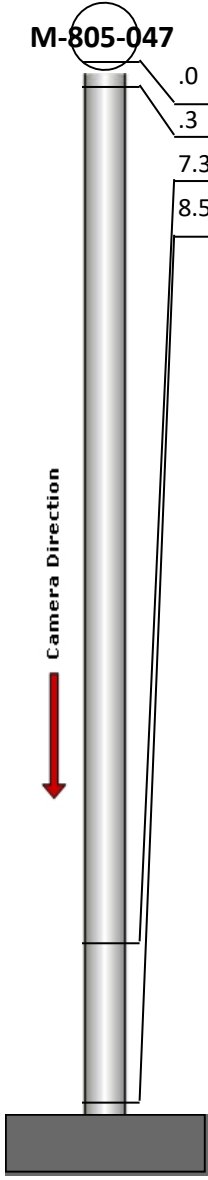
.0	MGP	General Photo	10	NA
	.3	DB	Displaced Brick	22	S 3
	7.3	DSF	Deposits Settled Fine	48	M 2
	8.5	MGO	General Observation	61	NA
