Manhole Inspection Report

Date:	05/06/2018	Weather:		Coding:	RZMACP
MH#:	M-805-049	Owner:	NA	Len. Surveyed:	10.1
P.O.#:		Surveyor:	Jen Costello	Rim to Invert:	10.8
Customer:		Cert. #:	U-907-5518	Wall Material:	Concrete (reinforced)

Street:	Intersection of Georgiana St. and H	Project:	Hobart, IN
City:	Hobart, IN	GPS Northing:	2907581.363
Location:		GPS Easting:	2907581.363
Drain Area:	South	GPS Accuracy:	Sub-Meter
Cover Shape:	Circular	Evidence of Surcharge:	No
Cover Size:	22.5	Potential for Runoff:	None
Comments:

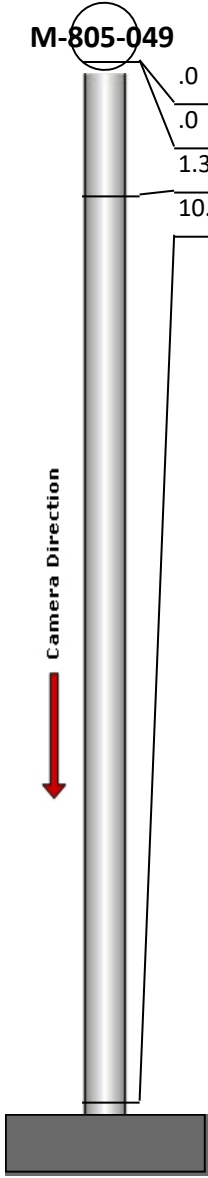
.0	CM	Crack Multiple	10	S 3
	.0	MGO	General Observation	22	NA
	1.3	MGO	General Observation	38	NA
	10.1	MGO	General Observation	68	NA
