Manhole Inspection Report

Date:	05/06/2018	Weather:		Coding:	RZMACP
MH#:	M-805-055.2	Owner:	NA	Len. Surveyed:	3.7
P.O.#:		Surveyor:	Jen Costello	Rim to Invert:	4.0
Customer:		Cert. #:	U-907-5518	Wall Material:	Brick

Street:	71' South of Cleveland Ave. and Wes	Project:	Hobart, IN
City:	Hobart, IN	GPS Northing:	2907412.128
Location:		GPS Easting:	2907412.128
Drain Area:	South	GPS Accuracy:	Sub-Meter
Cover Shape:	Circular	Evidence of Surcharge:	No
Cover Size:	22.5	Potential for Runoff:	None
Comments:

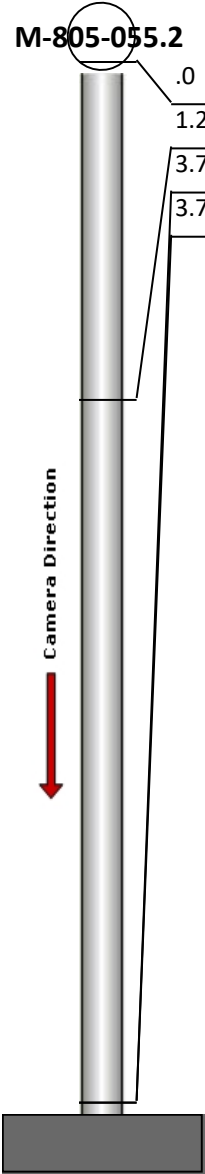
M-805-055.2				
	.0	MGP	General Photo	10	NA
	1.2	MGO	General Observation	26	NA
	3.7	DSF	Deposits Settled Fine	44	M 2
	3.7	MGO	General Observation	55	NA
