Manhole Inspection Report

Date:	05/07/2018	Weather:		Coding:	RZMACP
MH#:	M-805-060	Owner:	NA	Len. Surveyed:	9.0
P.O.#:		Surveyor:	Jen Costello	Rim to Invert:	10.2
Customer:		Cert. #:	U-907-5518	Wall Material:	Concrete (reinforced)

Street:	Intersection of Devonshire St. and O	Project:	Hobart, IN
City:	Hobart, IN	GPS Northing:	2908377.36
Location:		GPS Easting:	2908377.36
Drain Area:	South	GPS Accuracy:	Sub-Meter
Cover Shape:	Circular	Evidence of Surcharge:	No
Cover Size:	22.5	Potential for Runoff:	None
Comments:

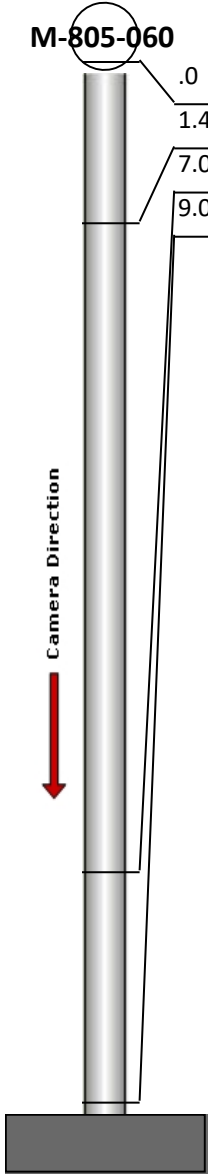
Position	Code	Observation	Video (sec)	Grade

.0	MGP	General Photo	10	NA
	1.4	MGO	General Observation	26	NA
	7.0	DSF	Deposits Settled Fine	51	M 2
	9.0	MGO	General Observation	66	NA
