# Manhole Inspection Report

Date:	05/06/2018	Weather:		Coding:	RZMACP
MH#:	M-805-065	Owner:	NA	Len. Surveyed:	2.2
P.O.#:		Surveyor:	`	Rim to Invert:	3.1
Customer:		Cert. #:	U-907-5518	Wall Material:	Concrete (reinforced)

Street:	On North St. 218' West of S. Indiana	Project:	Hobart, IN
City:	Hobart, IN	GPS Northing:	2907759.722
Location:		GPS Easting:	2907759.722
Drain Area:	South	GPS Accuracy:	Sub-Meter
Cover Shape:	Circular	Evidence of Surcharge:	No
Cover Size:	22.5	Potential for Runoff:	None
Comments:

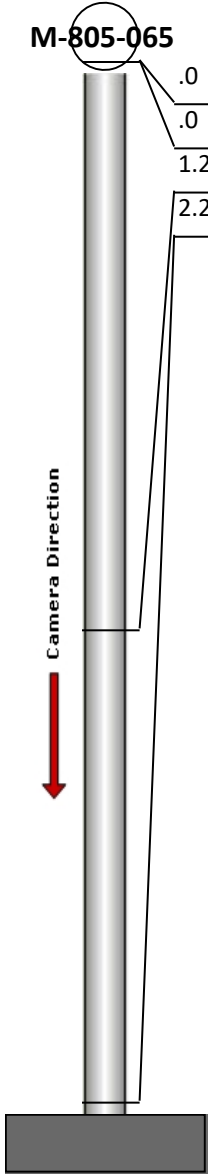
.0	MGP	General Photo	10	NA
	.0	SAV	Surface Aggregate Visible	21	S 3
	1.2	DSF	Deposits Settled Fine	35	M 2
	2.2	MGO	General Observation	49	NA
