Manhole Inspection Report

Date:	04/20/2018	Weather:		Coding:	RZMACP
MH#:	M-806-002	Owner:	NA	Len. Surveyed:	6.7
P.O.#:		Surveyor:	John Kuglmaier	Rim to Invert:	7.0
Customer:		Cert. #:	U-1215-07002349	Wall Material:	Concrete (reinforced)

Street:	Luther St. 410' North of 10th St.	Project:	Hobart, IN
City:	Hobart, IN	GPS Northing:	2908309.69
Location:		GPS Easting:	2908309.69
Drain Area:	Southeast	GPS Accuracy:	Sub-Meter
Cover Shape:	Circular	Evidence of Surcharge:	No
Cover Size:	22.5	Potential for Runoff:	None
Comments:

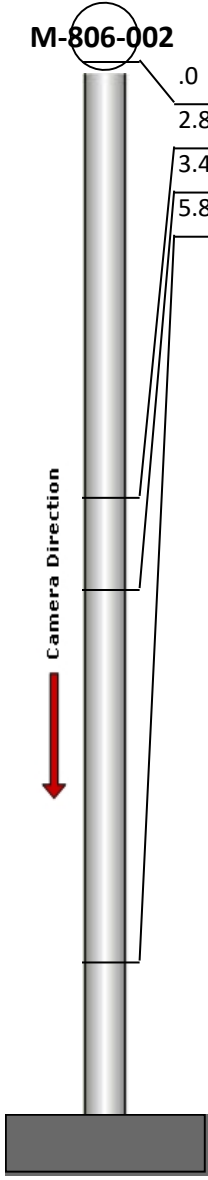
Position	Code	Observation	Video (sec)	Grade

.0	MGP	General Photo	10	NA
	2.8	MGP	General Photo	29	NA
	3.4	DAZ	Deposits Attached Other	44	M 2
	5.8	MGO	General Observation	60	NA
