Manhole Inspection Report

Date:	04/20/2018	Weather:		Coding:	RZMACP
MH#:	M-806-004	Owner:	NA	Len. Surveyed:	8.2
P.O.#:		Surveyor:	John Kuglmaier	Rim to Invert:	8.0
Customer:		Cert. #:	U-1215-07002349	Wall Material:	Concrete (reinforced)

Street:	On Luther St. 473' Southwest of 8th	Project:	Hobart, IN
City:	Hobart, IN	GPS Northing:	0.0
Location:		GPS Easting:	0.0
Drain Area:	Southeast	GPS Accuracy:	Nearest Meter
Cover Shape:	Circular	Evidence of Surcharge:	Yes
Cover Size:	22.5	Potential for Runoff:	None
Comments:

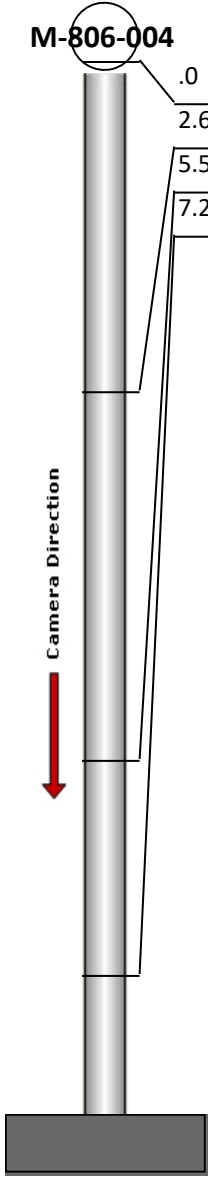
.0	MGP	General Photo	10	NA
	2.6	MGP	General Photo	29	NA
	5.5	DAZ	Deposits Attached Other	48	M 3
	7.2	MGO	General Observation	63	NA
