Manhole Inspection Report

Date:	04/20/2018	Weather:		Coding:	RZMACP
MH#:	M-806-005	Owner:	NA	Len. Surveyed:	8.1
P.O.#:		Surveyor:	John Kuglmaier	Rim to Invert:	7.9
Customer:		Cert. #:	U-1215-07002349	Wall Material:	Concrete (reinforced)

Street:	Luther St. 299' South of 8th St.	Project:	Hobart, IN
City:	Hobart, IN	GPS Northing:	2908291.458
Location:		GPS Easting:	2908291.458
Drain Area:	Southeast	GPS Accuracy:	Sub-Meter
Cover Shape:	Circular	Evidence of Surcharge:	No
Cover Size:	22.5	Potential for Runoff:	None
Comments:

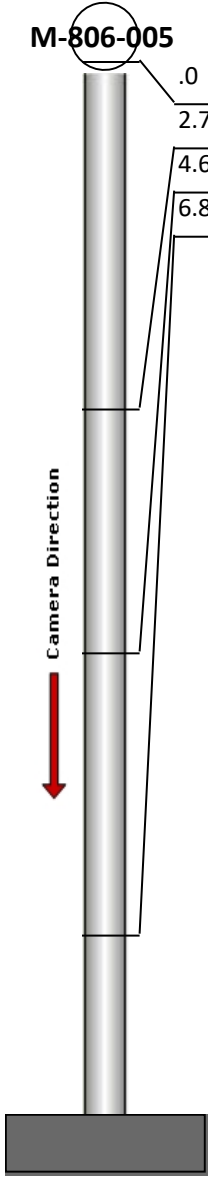
.0	MGP	General Photo	10	NA
	2.7	MGP	General Photo	29	NA
	4.6	DAZ	Deposits Attached Other	46	M 2
	6.8	MGO	General Observation	62	NA
