Manhole Inspection Report

Date:	04/20/2018	Weather:		Coding:	RZMACP
MH#:	M-806-007	Owner:	NA	Len. Surveyed:	11.2
P.O.#:		Surveyor:	John Kuglmaier	Rim to Invert:	10.8
Customer:		Cert. #:	U-1215-07002349	Wall Material:	Concrete (reinforced)

Street:	8th St. 223' East of Memory Ln.	Project:	Hobart, IN
City:	Hobart, IN	GPS Northing:	2908206.846
Location:		GPS Easting:	2908206.846
Drain Area:	Southeast	GPS Accuracy:	Sub-Meter
Cover Shape:	Circular	Evidence of Surcharge:	No
Cover Size:	22.5	Potential for Runoff:	None
Comments:

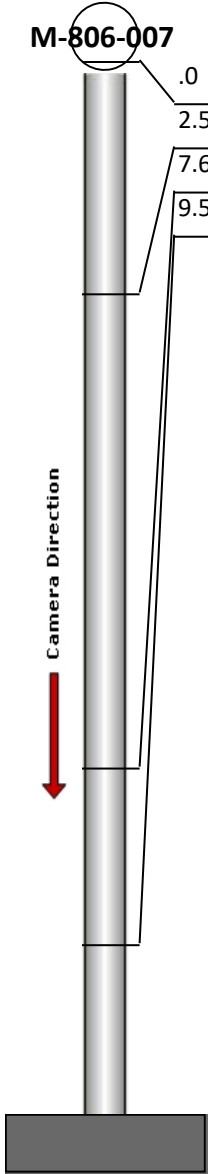
Position	Code	Observation	Video (sec)	Grade

.0	MGP	General Photo	10	NA
	2.5	MGP	General Photo	29	NA
	7.6	DAZ	Deposits Attached Other	52	M 3
	9.5	MGO	General Observation	68	NA
