Manhole Inspection Report

Date:	04/20/2018	Weather:		Coding:	RZMACP
MH#:	M-806-008	Owner:	NA	Len. Surveyed:	3.3
P.O.#:		Surveyor:	Jen Costello	Rim to Invert:	3.3
Customer:		Cert. #:	U-907-5518	Wall Material:	Concrete (reinforced)

Street:	North of 8th St. 237' East of Memor	Project:	Hobart, IN
City:	Hobart, IN	GPS Northing:	2908218.068
Location:		GPS Easting:	2908218.068
Drain Area:	Southeast	GPS Accuracy:	Sub-Meter
Cover Shape:	Circular	Evidence of Surcharge:	No
Cover Size:	22.5	Potential for Runoff:	None
Comments:

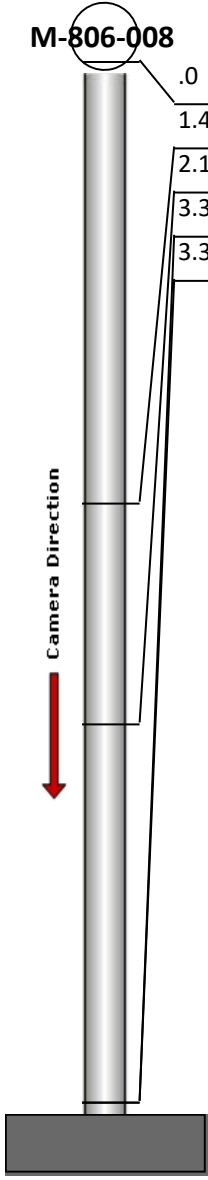
Position	Code	Observation	Video (sec)	Grade

.0	MGO	General Observation	10	NA
	1.4	MGO	General Observation	26	NA
	2.1	FL	Fracture Longitudinal	41	S 3
	3.3	DSF	Deposits Settled Fine	56	M 2
	3.3	MGO	General Observation	67	NA
