Manhole Inspection Report

Date:	04/20/2018	Weather:		Coding:	RZMACP
MH#:	M-806-009	Owner:	NA	Len. Surveyed:	13.8
P.O.#:		Surveyor:	John Kuglmaier	Rim to Invert:	15.4
Customer:		Cert. #:	U-1215-07002349	Wall Material:	Concrete (reinforced)

Street:	North of 8th St. 162' East of Memor	Project:	Hobart, IN
City:	Hobart, IN	GPS Northing:	2908167.633
Location:		GPS Easting:	2908167.633
Drain Area:	Southeast	GPS Accuracy:	Sub-Meter
Cover Shape:	Circular	Evidence of Surcharge:	No
Cover Size:	22.5	Potential for Runoff:	None
Comments:

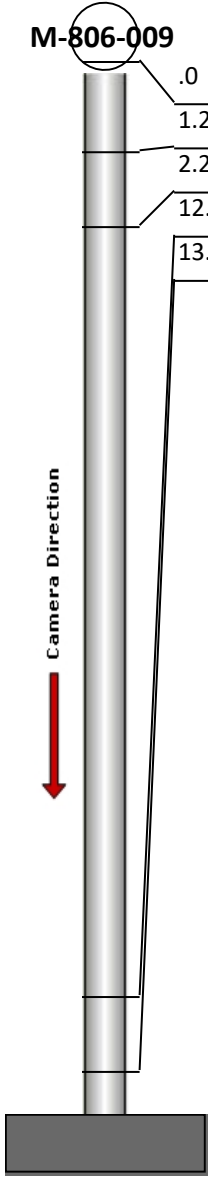
.0	MGP	General Photo	10	NA
	1.2	IS	Infil Stain	24	NA
	2.2	MGP	General Photo	40	NA
	12.4	DAZ	Deposits Attached Other	74	M 2
	13.4	MGO	General Observation	88	NA
