Manhole Inspection Report

Date:	04/21/2018	Weather:		Coding:	RZMACP
MH#:	M-806-030	Owner:	NA	Len. Surveyed:	7.8
P.O.#:		Surveyor:	John Kuglmaier	Rim to Invert:	7.9
Customer:		Cert. #:	U-1215-07002349	Wall Material:	Concrete (reinforced)

Street:	9th Ct. off of Springdale Dr.	Project:	Hobart, IN
City:	Hobart, IN	GPS Northing:	0.0
Location:		GPS Easting:	0.0
Drain Area:	Southeast	GPS Accuracy:	Nearest Meter
Cover Shape:	Circular	Evidence of Surcharge:	No
Cover Size:	22.5	Potential for Runoff:	None
Comments:

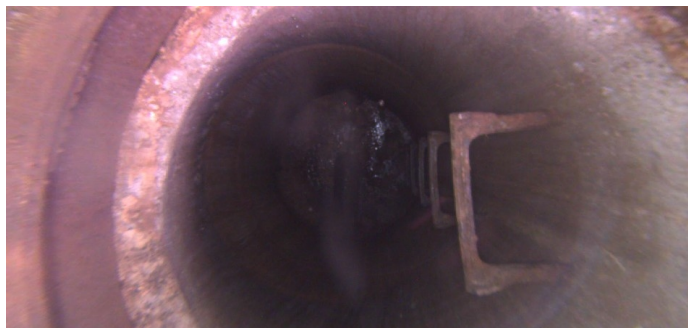
Code: **MGP**
Description: **General Photo**

Distance (ft): **.0**
Structural Grade: **0**
O&M Grade: **0**
Clock Start/From:
Clock To:
1st Value:
2nd Value:
Value Percent:
Step: **NO**
Remarks:

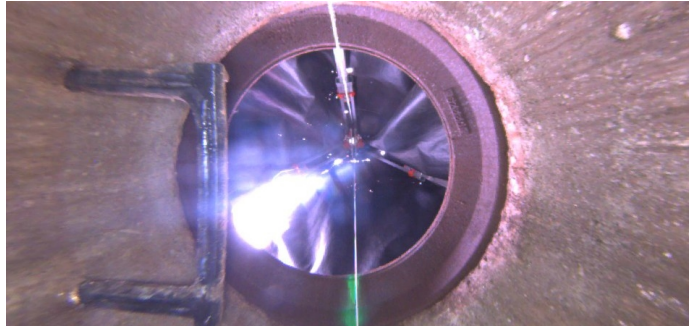
Code: **MGP**
Description: **General Photo**

Distance (ft): **2.8**
Structural Grade: **0**
O&M Grade: **0**
Clock Start/From:
Clock To:
1st Value:
2nd Value:
Value Percent:
Step: **NO**
Remarks:

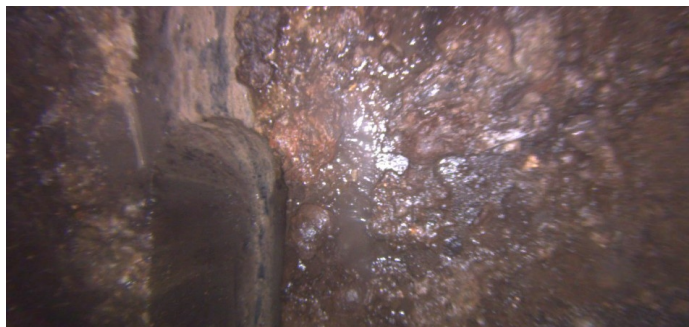
Code: **MGO**
Description: **General Observation**

Distance (ft): **6.9**
Structural Grade: **0**
O&M Grade: **0**
Clock Start/From:
Clock To:
1st Value:
2nd Value:
Value Percent:
Step: **NO**
Remarks: **Ins. Comp.**
