Manhole Inspection Report

Date:	04/21/2018	Weather:		Coding:	RZMACP
MH#:	M-806-031	Owner:	NA	Len. Surveyed:	7.6
P.O.#:		Surveyor:	John Kuglmaier	Rim to Invert:	7.7
Customer:		Cert. #:	U-1215-07002349	Wall Material:	Concrete (reinforced)

Street:	Springdale Dr. 291' South of 9th Ct.	Project:	Hobart, IN
City:	Hobart, IN	GPS Northing:	0.0
Location:		GPS Easting:	0.0
Drain Area:	Southeast	GPS Accuracy:	Nearest Meter
Cover Shape:	Circular	Evidence of Surcharge:	No
Cover Size:	22.5	Potential for Runoff:	None
Comments:

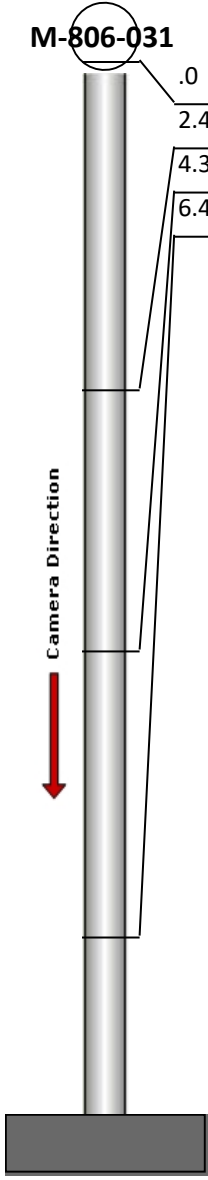
Position	Code	Observation	Video (sec)	Grade

.0	MGP	General Photo	10	NA
	2.4	MGP	General Photo	29	NA
	4.3	DSF	Deposits Settled Fine	46	M 2
	6.4	MGO	General Observation	62	NA
