Manhole Inspection Report

Date:	04/21/2018	Weather:		Coding:	RZMACP
MH#:	M-806-032	Owner:	NA	Len. Surveyed:	7.8
P.O.#:		Surveyor:	John Kuglmaier	Rim to Invert:	7.7
Customer:		Cert. #:	U-1215-07002349	Wall Material:	Concrete (reinforced)

Street:	Springdale Dr. 119' North of 10th St.	Project:	Hobart, IN
City:	Hobart, IN	GPS Northing:	0.0
Location:		GPS Easting:	0.0
Drain Area:	Southeast	GPS Accuracy:	Nearest Meter
Cover Shape:	Circular	Evidence of Surcharge:	No
Cover Size:	22.5	Potential for Runoff:	None
Comments:

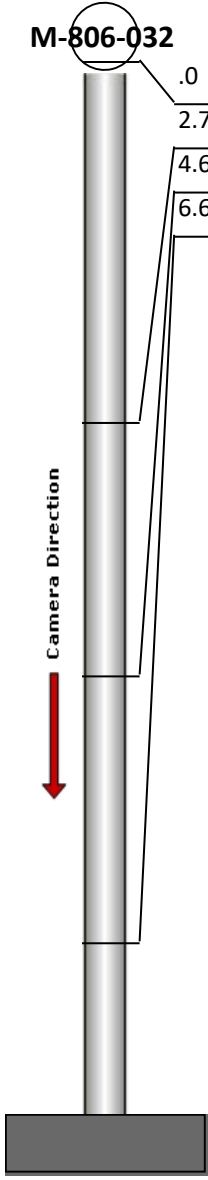
.0	MGP	General Photo	10	NA
	2.7	MGP	General Photo	29	NA
	4.6	DSF	Deposits Settled Fine	47	M 2
	6.6	MGO	General Observation	62	NA
