Manhole Inspection Report

Date:	04/21/2018	Weather:		Coding:	RZMACP
MH#:	M-806-042	Owner:	NA	Len. Surveyed:	4.5
P.O.#:		Surveyor:	John Kuglmaier	Rim to Invert:	4.7
Customer:	8.7	Cert. #:	U-1215-07002349	Wall Material:	Concrete (reinforced)

Street:	10th St. 176' East of Hobart Rd.	Project:	Hobart, IN
City:	Hobart, IN	GPS Northing:	0.0
Location:		GPS Easting:	0.0
Drain Area:	Southeast	GPS Accuracy:	Nearest Meter
Cover Shape:	Circular	Evidence of Surcharge:	No
Cover Size:	22.5	Potential for Runoff:	None
Comments:

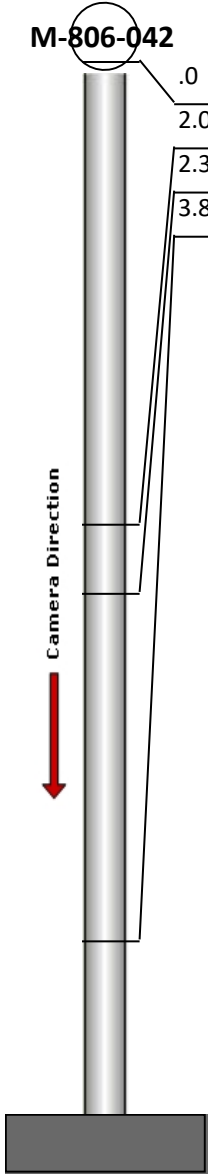
Position	Code	Observation	Video (sec)	Grade

.0	MGP	General Photo	10	NA
	2.0	DAZ	Deposits Attached Other	26	M 2
	2.3	MGP	General Photo	40	NA
	3.8	MGO	General Observation	57	NA
