Manhole Inspection Report

Date:	04/21/2018	Weather:		Coding:	RZMACP
MH#:	M-806-054	Owner:	NA	Len. Surveyed:	4.4
P.O.#:		Surveyor:	John Kuglmaier	Rim to Invert:	4.3
Customer:		Cert. #:	U-1215-07002349	Wall Material:	Concrete (reinforced)

Street:	518' East of Springdale Dr. 512' Nort	Project:	Hobart, IN
City:	Hobart, IN	GPS Northing:	0.0
Location:		GPS Easting:	0.0
Drain Area:	Southeast	GPS Accuracy:	Nearest Meter
Cover Shape:	Circular	Evidence of Surcharge:	No
Cover Size:	22.5	Potential for Runoff:	None
Comments:

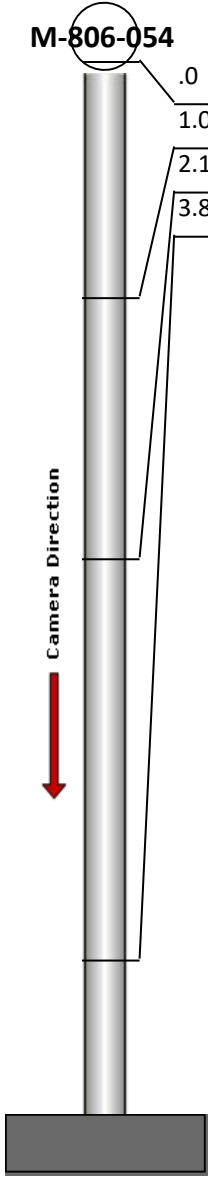
.0	MGP	General Photo	10	NA
	1.0	DSGV	Deposits Settled Gravel	24	M 2
	2.1	MGP	General Photo	40	NA
	3.8	MGO	General Observation	57	NA
