Manhole Inspection Report

Date:	04/21/2018	Weather:		Coding:	RZMACP
MH#:	M-806-056	Owner:	NA	Len. Surveyed:	4.2
P.O.#:		Surveyor:	John Kuglmaier	Rim to Invert:	4.2
Customer:		Cert. #:	U-1215-07002349	Wall Material:	Concrete (reinforced)

Street:	751' East of Springdale Dr. 601' Nort	Project:	Hobart, IN
City:	Hobart, IN	GPS Northing:	0.0
Location:		GPS Easting:	0.0
Drain Area:	Southeast	GPS Accuracy:	Nearest Meter
Cover Shape:	Circular	Evidence of Surcharge:	No
Cover Size:	22.5	Potential for Runoff:	None
Comments:

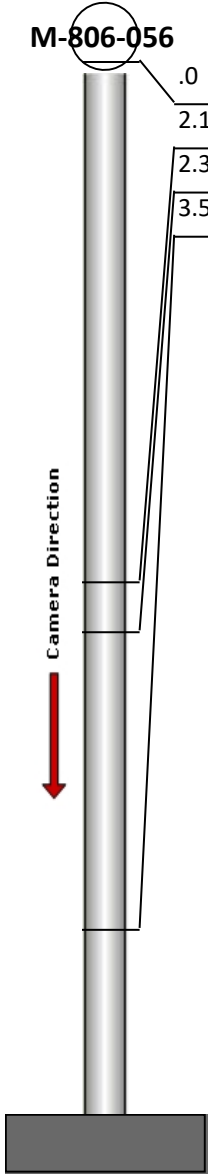
M-806-056				
	.0	MGP	General Photo	10	NA
	2.1	MGP	General Photo	28	NA
	2.3	DSF	Deposits Settled Fine	42	M 2
	3.5	MGO	General Observation	56	NA
