Manhole Inspection Report

Date:	04/20/2018	Weather:		Coding:	RZMACP
MH#:	M-806-065	Owner:	NA	Len. Surveyed:	6.1
P.O.#:		Surveyor:	John Kuglmaier	Rim to Invert:	5.7
Customer:		Cert. #:	U-1215-07002349	Wall Material:	Concrete (reinforced)

Street:	On Gilbert Ct. 317' South of 6th St.	Project:	Hobart, IN
City:	Hobart, IN	GPS Northing:	2907995.487
Location:		GPS Easting:	2907995.487
Drain Area:	Southeast	GPS Accuracy:	Sub-Meter
Cover Shape:	Circular	Evidence of Surcharge:	No
Cover Size:	22.5	Potential for Runoff:	None
Comments:

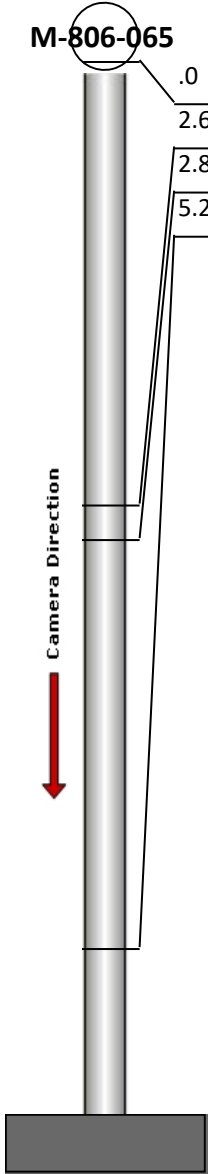
M-806-065				
	.0	MGP	General Photo	10	NA
	2.6	MGP	General Photo	29	NA
	2.8	DAZ	Deposits Attached Other	43	M 2
	5.2	MGO	General Observation	60	NA
