Manhole Inspection Report

Date:	04/18/2018	Weather:		Coding:	RZMACP
MH#:	M-807-013	Owner:	NA	Len. Surveyed:	2.3
P.O.#:		Surveyor:	Jen Costello	Rim to Invert:	3.0
Customer:		Cert. #:	U-907-5518	Wall Material:	Concrete (reinforced)

Street:	On 14th St. 328' East of Illinois St.	Project:	Hobart, IN
City:	Hobart, IN	GPS Northing:	0.0
Location:		GPS Easting:	0.0
Drain Area:	Southeast	GPS Accuracy:	Nearest Meter
Cover Shape:	Circular	Evidence of Surcharge:	No
Cover Size:	22.5	Potential for Runoff:	None
Comments:

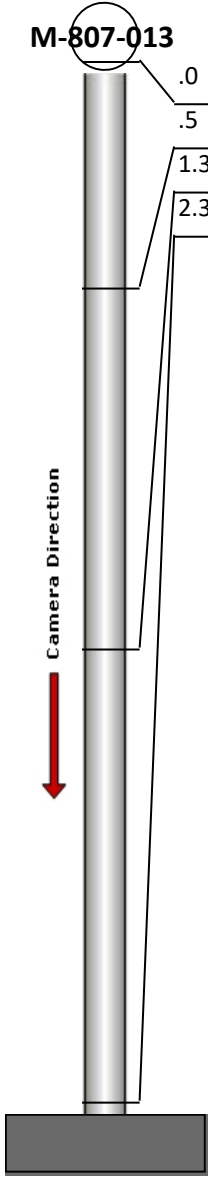
.0	MGO	General Observation	10	NA
	.5	FL	Fracture Longitudinal	22	S 3
	1.3	DSF	Deposits Settled Fine	35	M 2
	2.3	MGO	General Observation	48	NA
