Manhole Inspection Report

Date:	11/02/2022	Weather:		Coding:	RZMACP
MH#:	M-808-022	Owner:	NA	Len. Surveyed:	7.2
P.O.#:		Surveyor:	Jen Costello	Rim to Invert:	8.1
Customer:		Cert. #:	U-907-5518	Wall Material:	Concrete (non-reinforced)

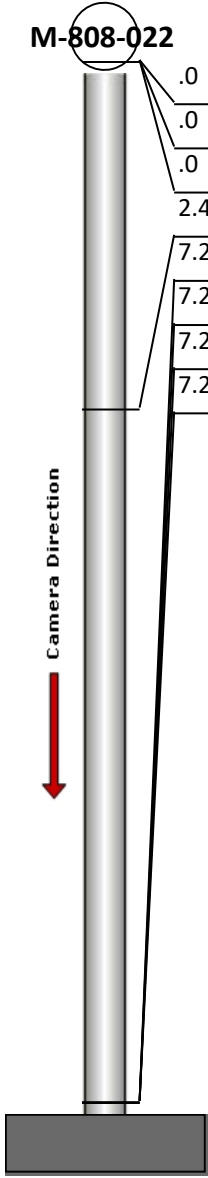
.0	RFJ	Roots Fine Joint	10	M 1
	.0	SRI	Surface Roughness Increased	21	S 1
	.0	MGO	General Observation	33	NA
	2.4	MGO	General Observation	51	NA
	7.2	MGO	General Observation	74	NA
	7.2	SRI	Surface Roughness Increased	85	S 1
	7.2	DSF	Deposits Settled Fine	96	M 2
	7.2	SAV	Surface Aggregate Visible	107	S 3
