Manhole Inspection Report

Date:	04/13/2018	Weather:		Coding:	RZMACP
MH#:	M-809-001	Owner:	NA	Len. Surveyed:	5.9
P.O.#:		Surveyor:	John Kuglmaier	Rim to Invert:	6.7
Customer:		Cert. #:	U-1215-07002349	Wall Material:	Concrete (reinforced)

Street:	Grosbeak Ct. South End of Cul DE Sa	Project:	Hobart, IN
City:	Hobart, IN	GPS Northing:	2908875.103
Location:		GPS Easting:	2908875.103
Drain Area:	Southwest	GPS Accuracy:	Sub-Meter
Cover Shape:	Circular	Evidence of Surcharge:	No
Cover Size:	22.5	Potential for Runoff:	None
Comments:

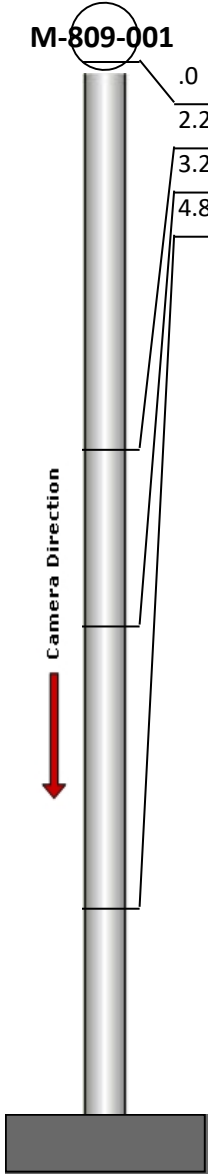
.0	MGP	General Photo	10	NA
	2.2	MGP	General Photo	28	NA
	3.2	DAZ	Deposits Attached Other	44	M 2
	4.8	MGO	General Observation	59	NA
