Manhole Inspection Report

Date:	04/13/2018	Weather:		Coding:	RZMACP
MH#:	M-809-002	Owner:	NA	Len. Surveyed:	5.9
P.O.#:		Surveyor:	John Kuglmaier	Rim to Invert:	6.9
Customer:		Cert. #:	U-1215-07002349	Wall Material:	Concrete (reinforced)

Street:	Grosbeak Ct. 367' South of Tanager	Project:	Hobart, IN
City:	Hobart, IN	GPS Northing:	2908877.576
Location:		GPS Easting:	2908877.576
Drain Area:	Southwest	GPS Accuracy:	Sub-Meter
Cover Shape:	Circular	Evidence of Surcharge:	No
Cover Size:	22.5	Potential for Runoff:	None
Comments:

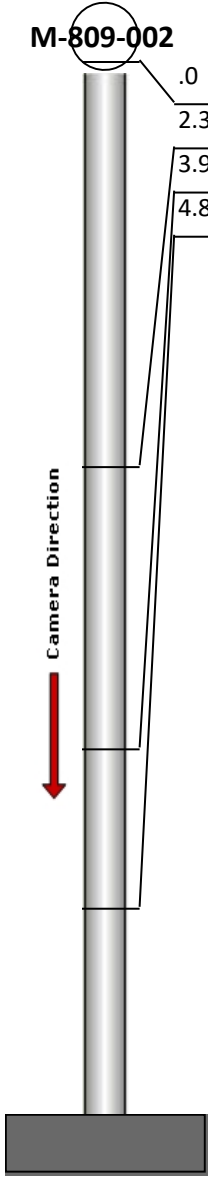
.0	MGP	General Photo	10	NA
	2.3	MGP	General Photo	28	NA
	3.9	OBZ	Obstacle Other	45	M 2
	4.8	MGO	General Observation	59	NA
