Manhole Inspection Report

| MH#: | M-809-009 | Owner: | NA | Len. Surveyed: | 8.8 |

| Street: | Grosbeak Ct. 171' North of Tanager | Project: | Hobart, IN |

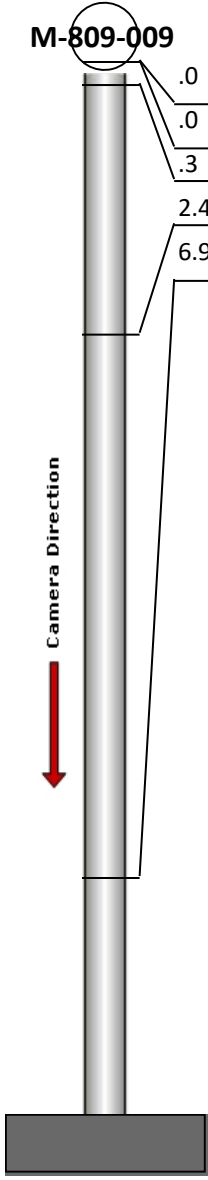
| | Position | Code | Observation | Video (sec) | Grade |
|--|---|---|---|---|---|
| | .0 | MGP | General Photo | 10 | NA |
| | .0 | RFJ | Roots Fine Joint | 22 | M 1 |
| | .3 | RFJ | Roots Fine Joint | 35 | M 1 |
| | 2.4 | MGP | General Photo | 53 | NA |
| | 6.9 | MGO | General Observation | 75 | NA |
