Manhole Inspection Report

Date:	04/13/2018	Weather:		Coding:	RZMACP
MH#:	M-809-011	Owner:	NA	Len. Surveyed:	9.3
P.O.#:		Surveyor:	John Kuglmaier	Rim to Invert:	9.8
Customer:		Cert. #:	U-1215-07002349	Wall Material:	Concrete (reinforced)

Street:	Grosbeak Ct. 358' North of Tanager	Project:	Hobart, IN
City:	Hobart, IN	GPS Northing:	2908912.956
Location:		GPS Easting:	2908912.956
Drain Area:	Southwest	GPS Accuracy:	Sub-Meter
Cover Shape:	Circular	Evidence of Surcharge:	No
Cover Size:	22.5	Potential for Runoff:	None
Comments:

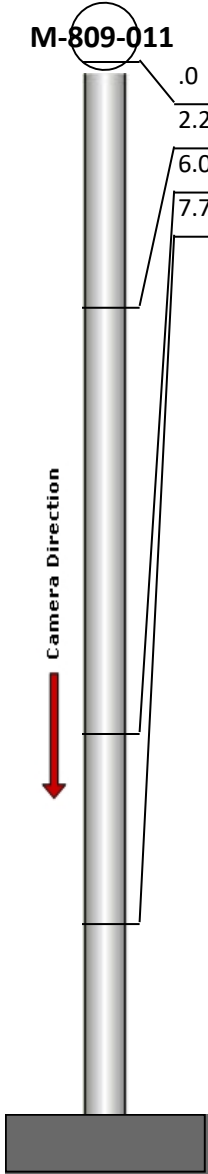
.0	MGP	General Photo	10	NA
	2.2	MGP	General Photo	28	NA
	6.0	DAZ	Deposits Attached Other	50	M 2
	7.7	MGO	General Observation	65	NA
